POLK COUNTY HEALTH DEPARTMENT

Field ReportBarrett, Haentjens & Company
Hazleton, Pennsylvania 18201

FIELD REPORT ON BARRETT, HAENTJENS, & COMPANY OF FLORIDA

REASON FOR VISIT Make gamma map of company built on reclaimed phosphate land.

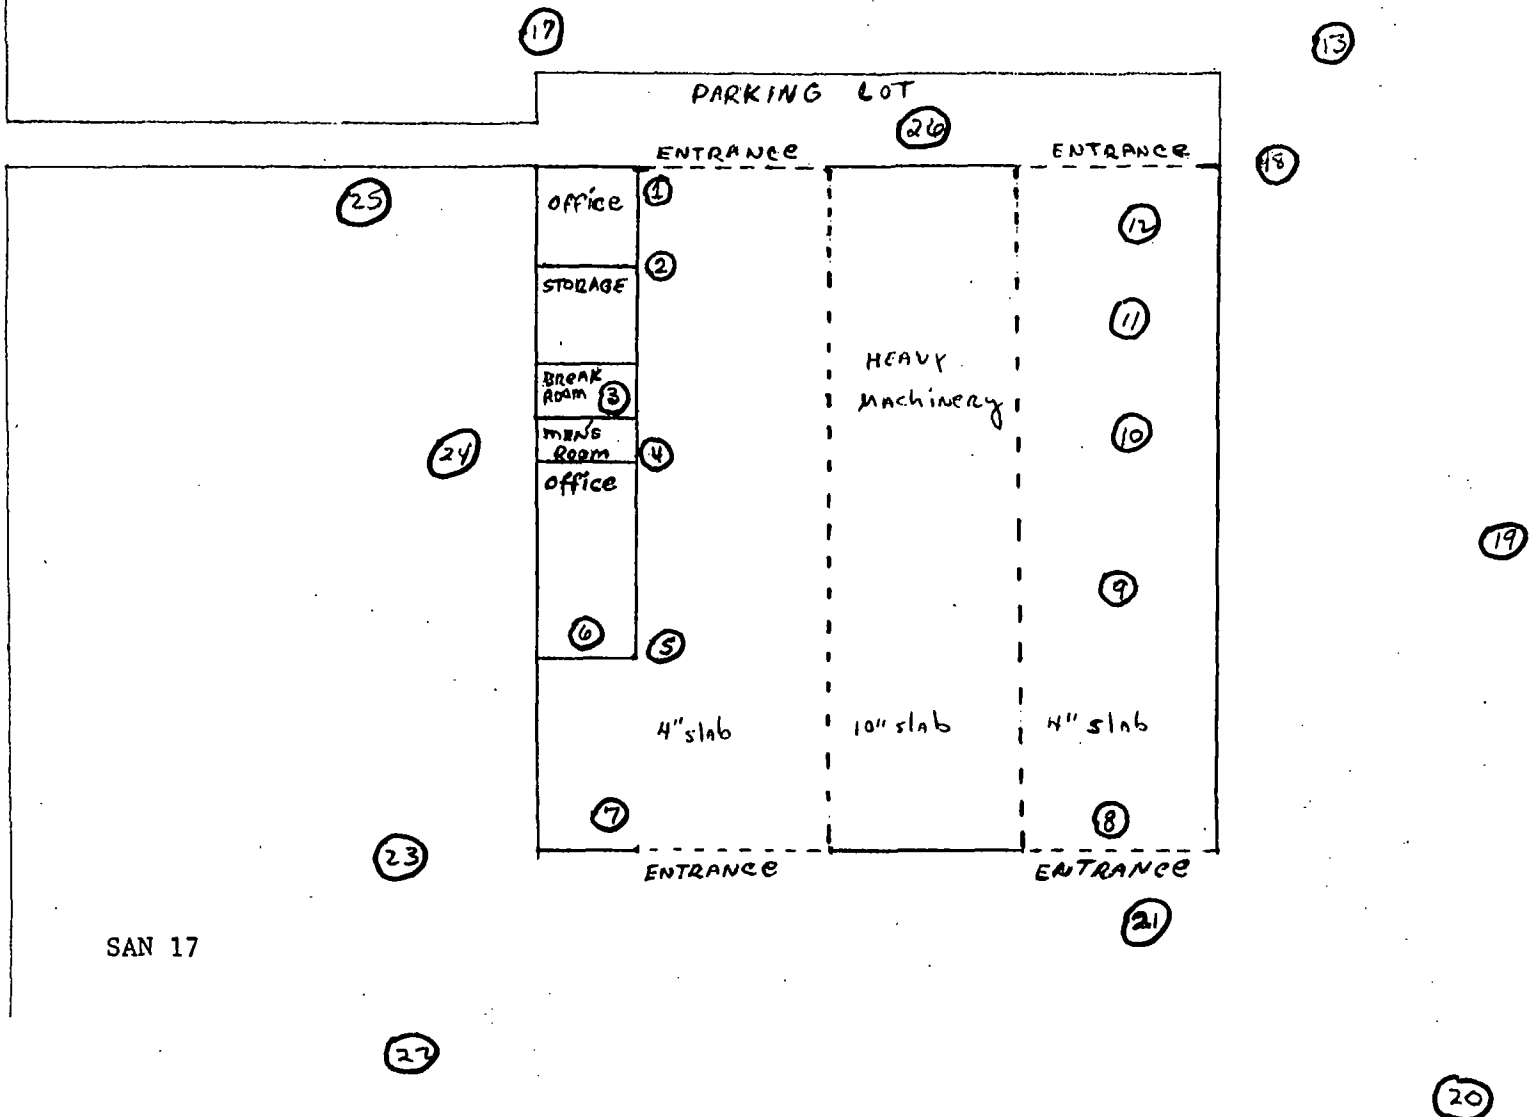
As compared to the guideline, the readings taken at your plant do not meet the 10 uR/hr radiation level. But I would like to point out that the interim recommendations purpose is to limit radon daughter exposures in structures constructed on Florida phosphate lands.

Although your plant has elevated gamma readings it is doubtful that you would have a large buildup of Radon 222 in your plant due to its construction.

I am making reference to the large entrances at both ends of your plant. These large openings should provide more than adequate ventilation for a structure of this size. We are in the process of obtaining equipment which will measure the amount of Radon present in a structure. This equipment should arrive later this summer. At that time we would be glad to further our investigation of your plant for you.

Column A	1 - 10.0
numbered	2 - 10.0
1-26 corresponds	3 - 13.0
to positions	4 - 10.2
numbered on	5 - 9.9
the attached	6 - 11.9
map.	7 - 10.4
Column B	8 - 16.0
represents	9 - 10.0
readings at	10 - 9.5
these positions	11 - 10.4
in Micro-	12 - 10.4
Roentgen per	13 - 18.6
hour	14 - 8.9
	15 - 8.6
	16 - 18.6
	17 - 13.6
	18 - 40.9
	19 - 35.3
	20 - 20.5
	21 - 24.2
	22 - 22.3
	23 - 31.6
	24 - 33.5
	25 - 33.5
	26 - 10.2

Readings 1-12 were all taken inside the building. Reading No. 8 may be elevated due to its closeness to the edge of the slab. (Compare reading No. 8 to reading No. 21 with 21 being outside the structure and off the slab but having a close proximity to No. 8). All other readings were taken outside the building. Note at position 18 there were large amounts of what appeared to be furnace slag which normally has an elevated gamma reading. Readings 14 and 15 were taken at fairly large distances from the building and may be in an area that has not been disturbed by mining operations.

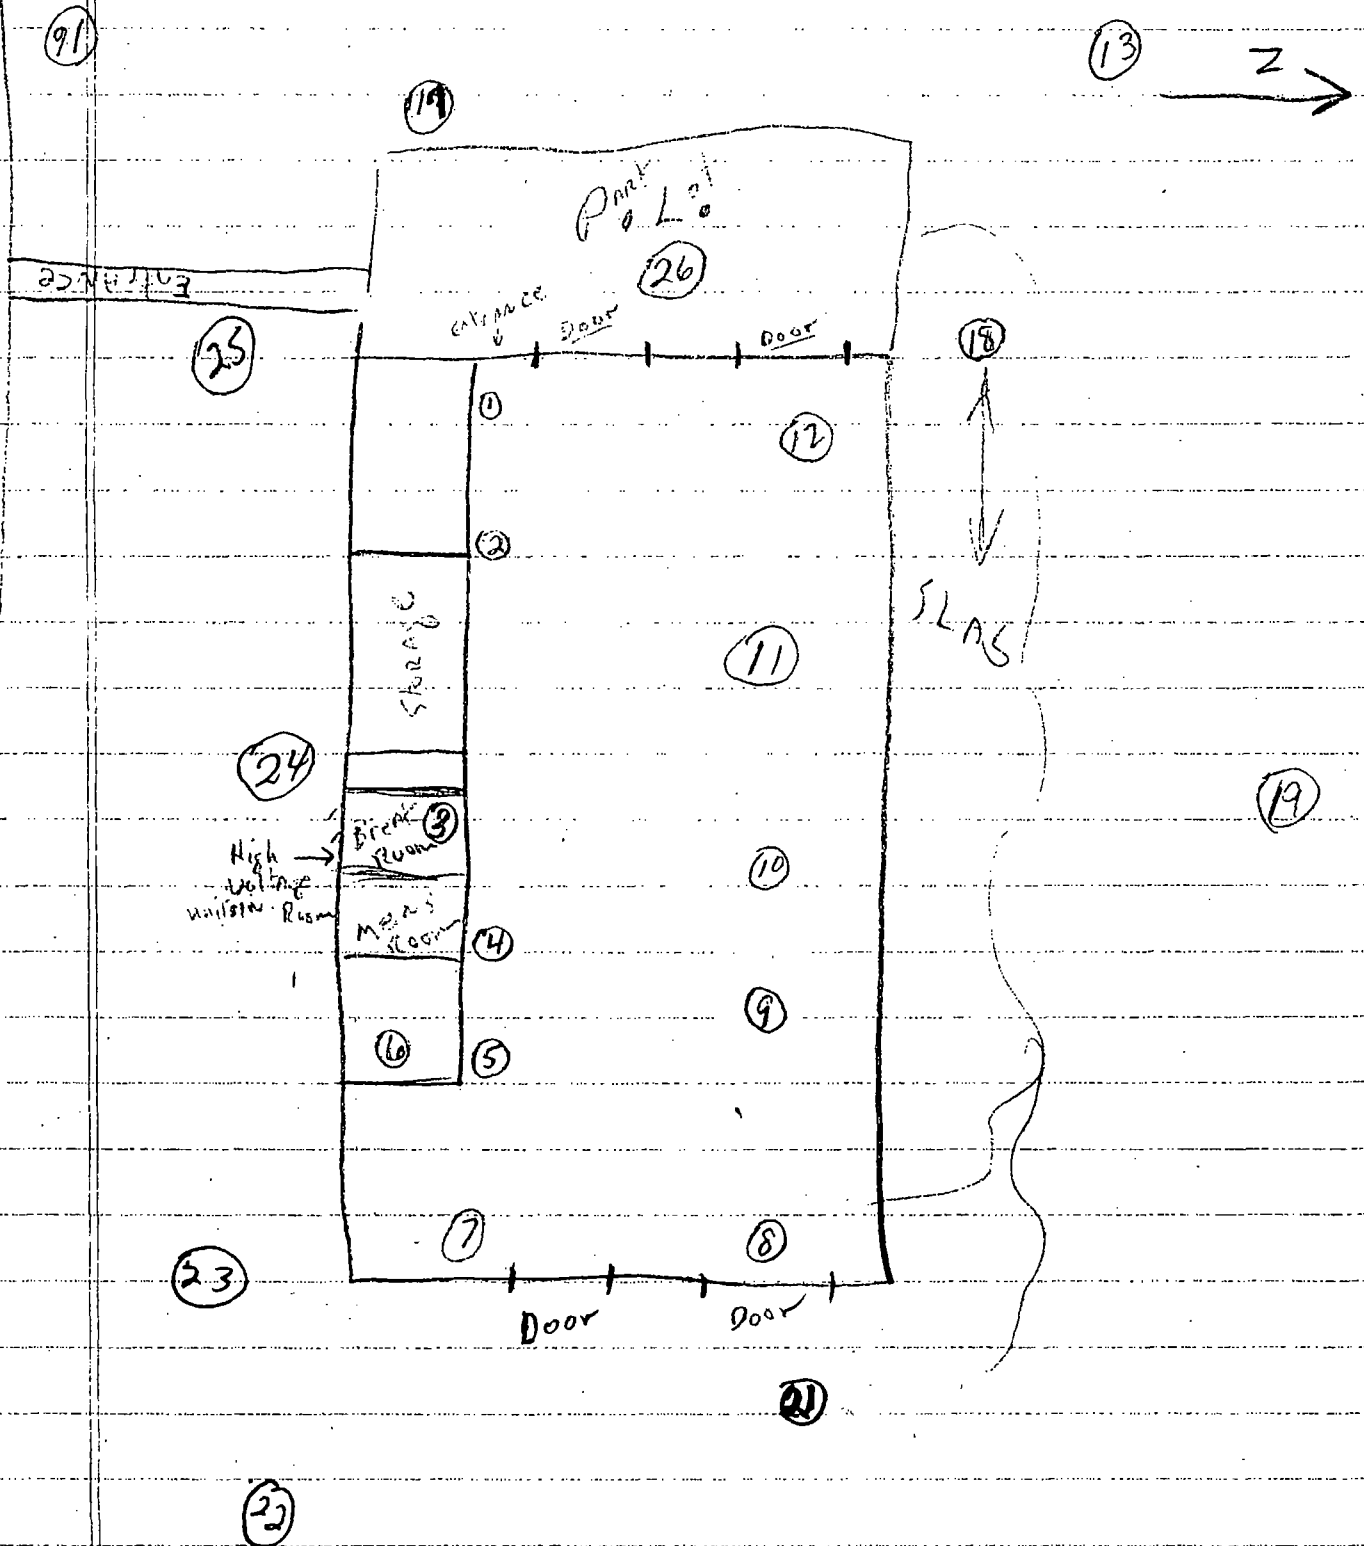
BARRETT, HAERTJENS & CO.

Readings 1-12 were all taken inside the Building. Reading No. 8 may be elevated due to its closeness to the edge of the slab. (Compare reading No 8 to Reading No 21 with 21 being outside the structure and off the slab but having a close proximity to No. 8). All other readings were taken outside the Building. Note at position 18 there were large amounts of what appeared to be furnace slag which normally has an elevated Gamma Reading. Readings 14 & 15 were taken at fairly large distances from the Building and may be in an area that has not been disturbed by mining operations.
